LARGE-SCALE PUMP REPAIR

See how Kennedy Industries disassembled, transported, repaired, and reinstalled the Byron Jackson Model 84 HXH, Low Lift No. 3 Pump at the Lake Huron Water Treatment Facility.

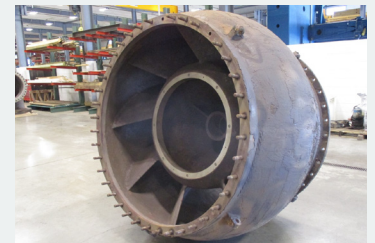
DIFFUSER

The diffuser bearing clearances were within specification, so they could be reused. The diffuser was set up in vertical turret lathe to have bearing bores and registers checked for concentricity and faces checked to ensure parallel.

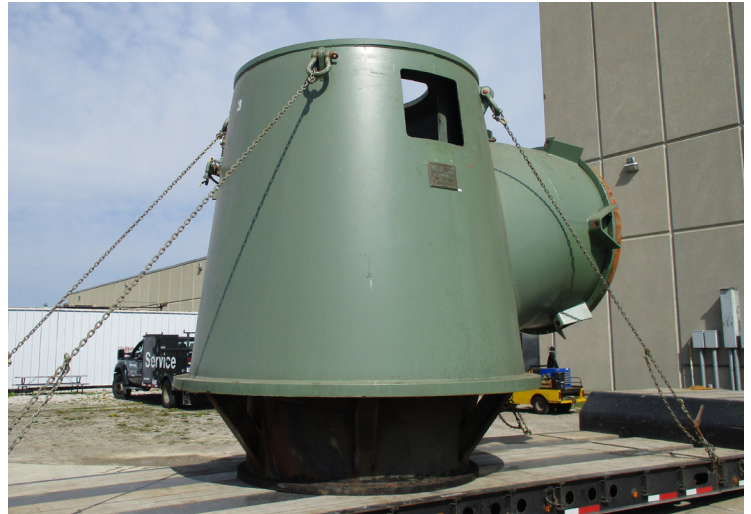
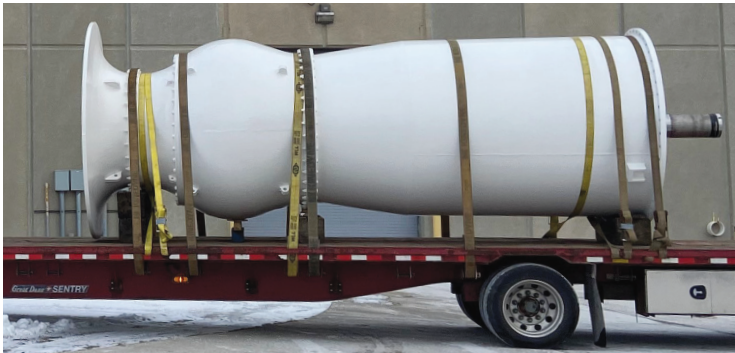
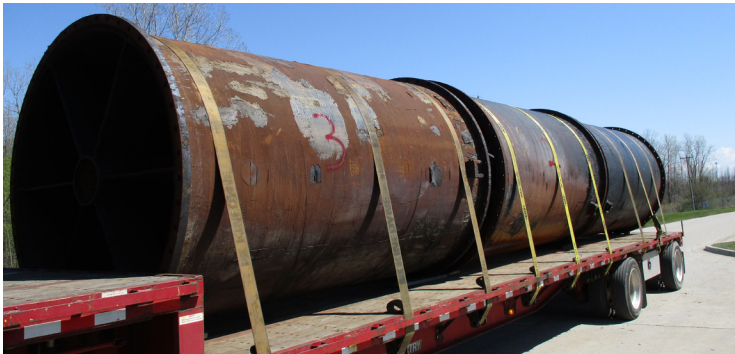
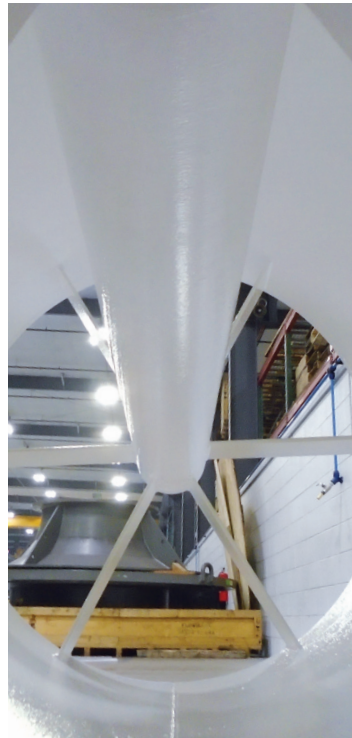
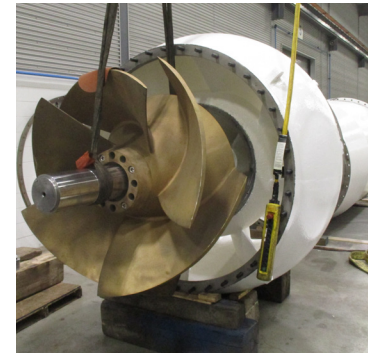
- CLOCKWISE FROM TOP:**
- 1) Dismantled pump head
 - 2) Refurbished impeller being assembled into diffuser
 - 3) Blasted and painted column
 - 4) Sections of original columns loaded for transit
 - 5) Finished bowl assembly ready for delivery.

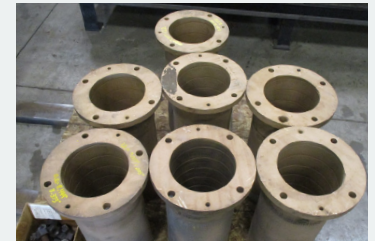
ENCLOSING TUBE BEARINGS

Enclosing tube bearings were measured and the clearance to the shafts were within specification. The enclosing tube bearings were also reused.

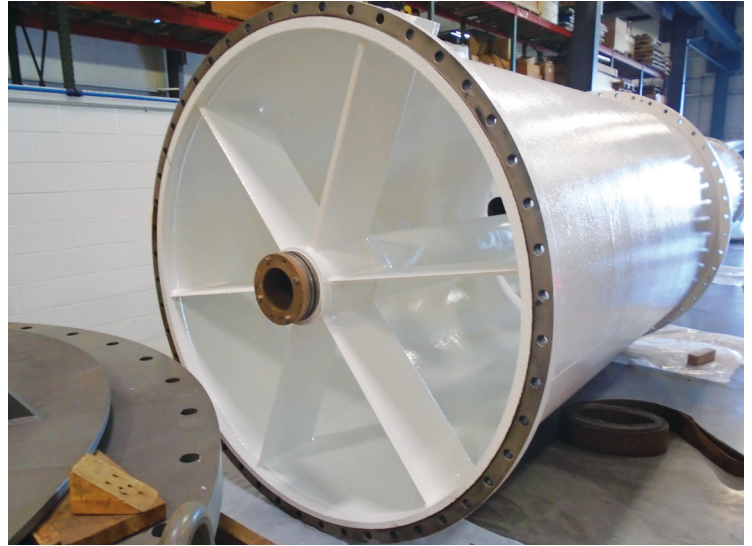
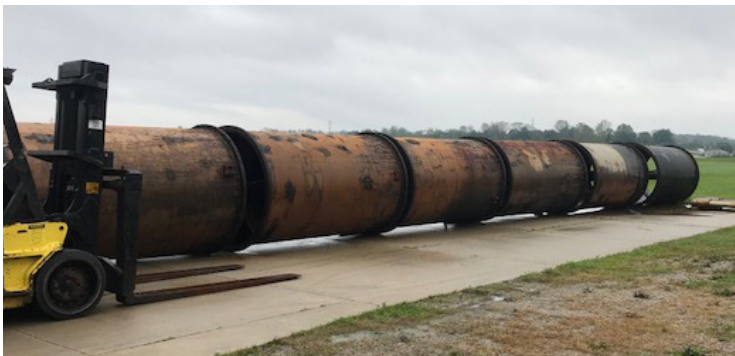
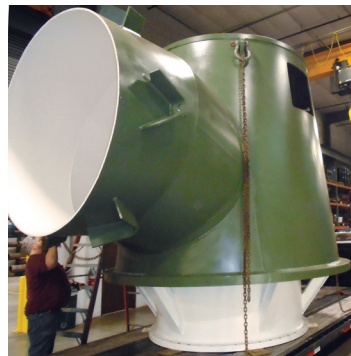
- CLOCKWISE FROM TOP:**
- 1) Cleaned, restored, and fully assembled bowl assembly
 - 2) Meticulously restored columns
 - 3) Pump head ready for delivery
 - 4) Sections of original columns in need of repair

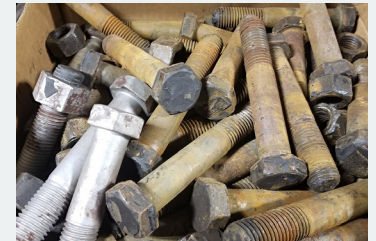
HARDWARE

All pump hardware was replaced with new to ensure long life and reliability.
