## Timely Intervention Saved a Critical Pump from Serious Harm

*A Michigan power plant had to act fast before facing imminent pump failure. A quick call to Kennedy Industries immediately got the wheels in motion for fast and lasting repair.*

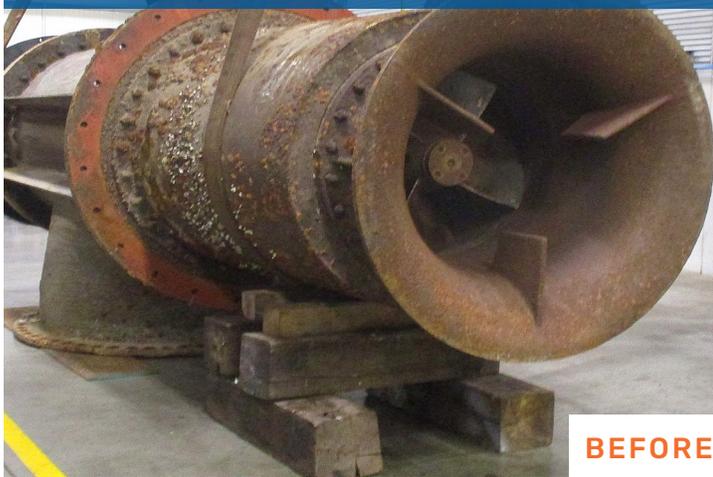
**BEFORE**

The power plant recently reported loud noises coming from one of their main condenser circulating water pumps. Kennedy Industries dispatched a field service engineer who promptly diagnosed extreme bearing wear, which caused the impeller to travel off its rotational centerline. Further investigation revealed that the pump had last been overhauled by Kennedy 18 years ago, far exceeding the recommended service interval. Facing a costly derate, the plant quickly removed the pump and Kennedy transported it to their repair facility for emergency disassembly, cleaning, and evaluation.
