## Attwood Marine's Lift Station Gets a Complete Overhaul

*A local marine Original Equipment Manufacturer needed servicing for their lift station, which was in an interior room without a ceiling and exposed to the atmosphere.*

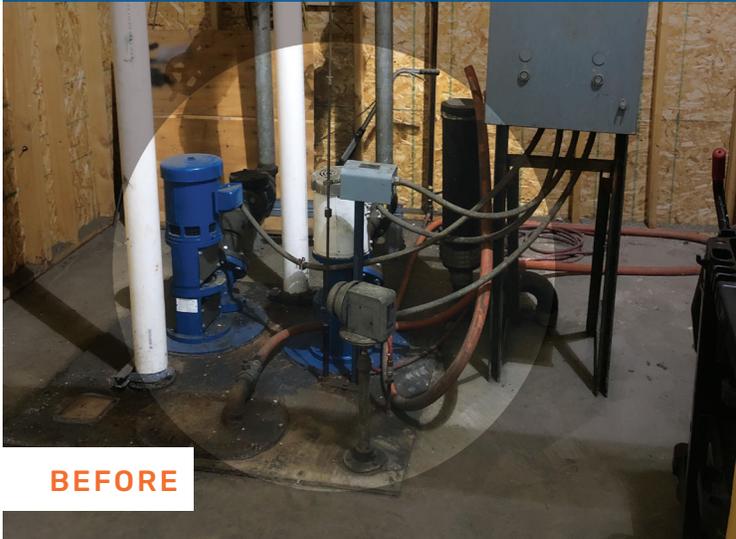
**BEFORE:** Two vertical sewage pumps were in need of serious repair to improve efficiency. Plus foul gases were escaping from an ill-fitting steel plate base.

**AFTER:** Two new state-of-the-art Concertor pumps with a new control panel, guide rails, check and gate valves, discharge piping and a new steel hatch for the station.
