## Enhancing Curb Appeal while Conforming to Electrical Code

*The lift station located just outside the visitor's entrance at a local marine equipment manufacturer's facility was well overdue for servicing, and frankly not very aesthetically appealing.*

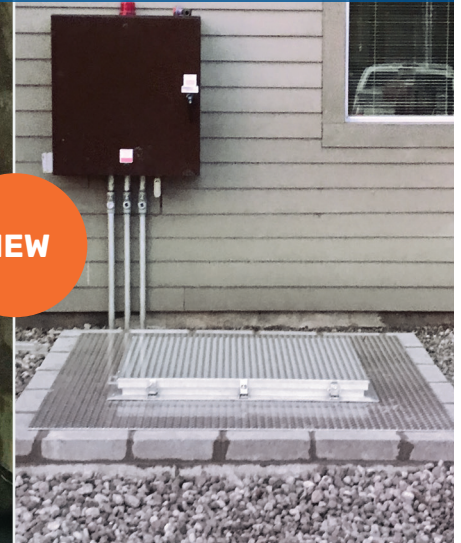
The station was old, outdated, and generally in poor condition. Located inside the station were two vertical sewage lift pumps that had seal and motor issues, as well as issues with their float system and pumps controls. One pump was completely unsalvageable. During the inspection, numerous electrical issues were found that accounted for a systemic hazardous condition. Exposed wiring and faulty pumps made for an explosive environment. The customer was not aware that the station did not conform to National Electrical Code and posed a considerable safety concern.

**ABOVE:** The rehabilitated lift station with two new state-of-the-art Concertor pumps, a new control panel, guide rails, check and gate valves, discharge piping and a new steel hatch for the station.  
**BOTTOM:** The original lift station.

Kennedy Industries' field service and sales teams devised a turnkey solution, which was to fully rehabilitate their station. Initially utilizing bypass pumping for the effluent coming into to the station, the team then installed two new state of the art Flygt Concertor pumps, including a new control panel, guide rails, pump bases, check and gate valves, floats and discharge piping. All electrical issues were addressed by the newly installed equipment and brought up to code. The customer also wanted to address the stations curb appeal, so during the site work old cinder blocks were removed, the control panel was moved closer to the building and a new hatch was installed to make the station flush with the grade.
