Expert Pump Repair Eases Pain for Mount Clemens WWTP

Kennedy's repair of malfunctioning pumps at the Mount Clemens Wastewater Treatment Plant, provides immediate relief from constant influent events and safety hazards.

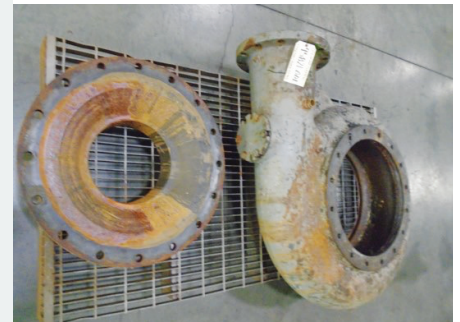
BEFORE: The volute and wear plate contributed to the reduction in efficiency. Registers of volute and wear ring are oversized by ½".
