Kennedy Repairs One of the Largest Pumps In Michigan

PUMP DATA

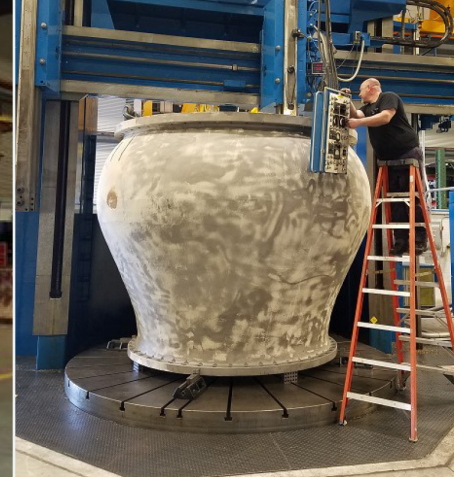
Indicating diffuser bowl to check concentricity of registers and machine case ring fit

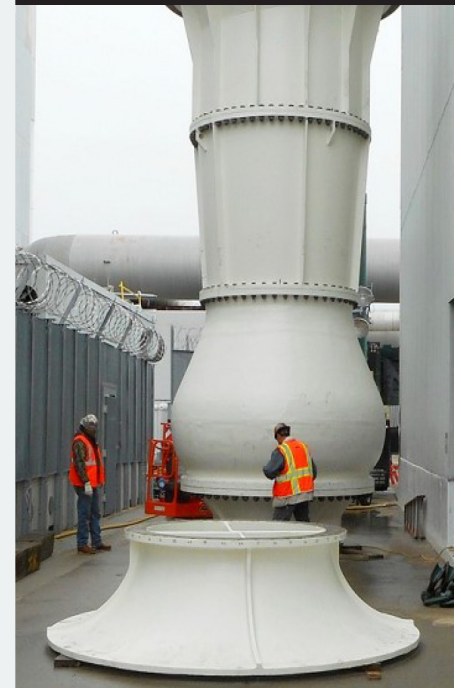
After being assembled outside pump is being lifted to install in pump basin
