PROJECT REPORT:

SKI AREA PUMP REPAIR MARCH 2021

Pump Repair Saves the Winter for a Local Michigan Ski Area

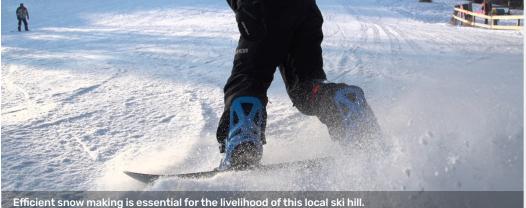
Upon arrival and disassembly, all pump components were glass bead blasted and precision inspected, along with non-destructive testing, shaft run-out checks, and concentricity checks on major components. Kennedy's repair team quickly found that 4 of the 8 pump impellers were damaged and that the bowl clearances were outside of factory specification. After completion of impeller welding, numerous machining processes, impeller balancing, critical component replacement, final cleaning, and an "as-built" inspection, the pump was reassembled in our 100,000 sq. ft. facility with all new hardware.

The field service team assisted the client with the installation of the pump and motor ensuring that the motor, coupling, and shaft were put in properly. They also aided the customer in starting up the pump and pressurizing the snow making system. The local ski hill was up and running well before cold temperatures returned. With the repaired pump in place, they soon made enough snow to cover their complete ski hill.

The rebuilt vertical turbine pump will be operating within this snow making system for many ski seasons to come.
