LARGE-SCALE PUMP REPAIR

See how Kennedy Industries disassembled, transported, repaired, and reinstalled the Byron Jackson Model 84 HXH, Low Lift No. 3 Pump at the Lake Huron Water Treatment Facility.

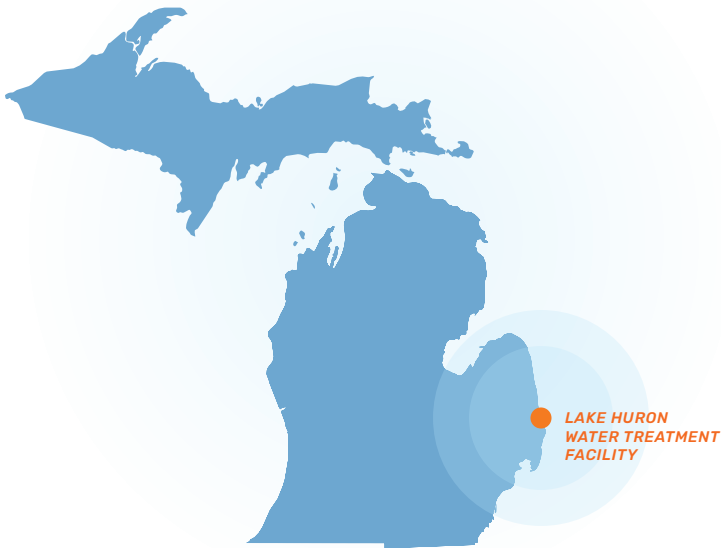
Great Lakes Water Authority (GLWA) called the Kennedy Industries Field Service Team to help evaluate why their Byron Jackson Model 84 HXH, Low Lift No. 3 Pump was overloading the 2250 HP Motor. We were able to reset the lift and get the 139,000 gpm pump back into operation.

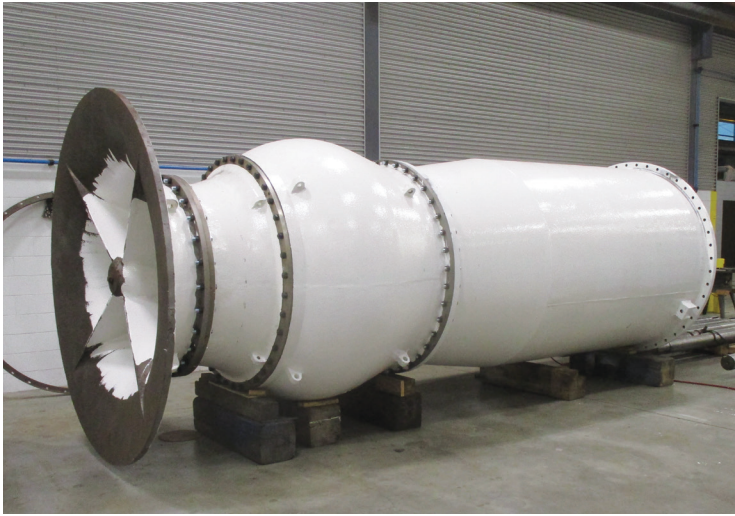
- CLOCKWISE FROM TOP:**
- 1) Cleaned, restored, and fully assembled bowl assembly
 - 2) Meticulously restored columns
 - 3) Pump head ready for delivery
 - 4) Sections of original columns in need of repair
