## Timely Intervention Saved a Critical Pump from Serious Harm

*A Michigan power plant had to act fast before facing imminent pump failure. A quick call to Kennedy Industries immediately got the wheels in motion for fast and lasting repair.*

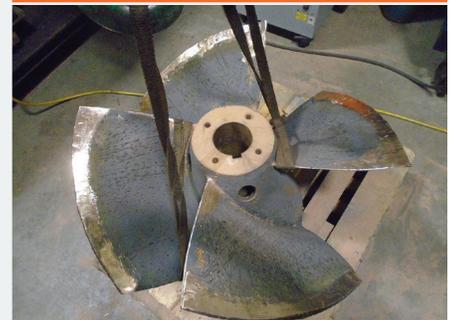
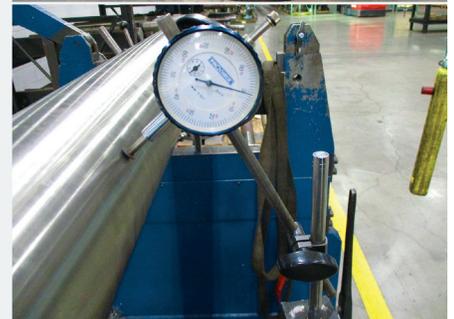
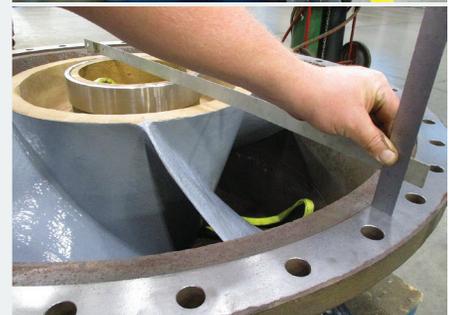
The power plant recently reported loud noises coming from one of their main condenser circulating water pumps. Kennedy Industries dispatched a field service engineer who promptly diagnosed extreme bearing wear, which caused the impeller to travel off its rotational centerline. Further investigation revealed that the pump had last been overhauled by Kennedy 18 years ago, far exceeding the recommended service interval. Facing a costly derate, the plant quickly removed the pump and Kennedy transported it to their repair facility for emergency disassembly, cleaning, and evaluation.

After completely dismantling the pump, all components were glass bead blasted and precision inspected. Kennedy also performed non-destructive testing, shaft run-out checks, and concentricity inspection on critical fits. We found that the major wear points were the pump shaft, bearings, sleeves, and impeller vane tips. Welding, machining processes, and component manufacturing were then initiated on an overtime basis. A ceramic coating was added to the impeller to resist erosion and improve efficiency. After impeller balancing, final cleaning, and quality control inspection were performed, the pump was reassembled in our 100,000 sq. ft facility with all new hardware.
