KENNEDY REPAIRS ONE OF THE LARGEST PUMPS IN MICHIGAN

PROBLEM: A cooling tower pump at a nuclear power plant was operating at low efficiency due to wear. The pump had been in service for 16 years. Kennedy Industries last repaired their pump in 2001.

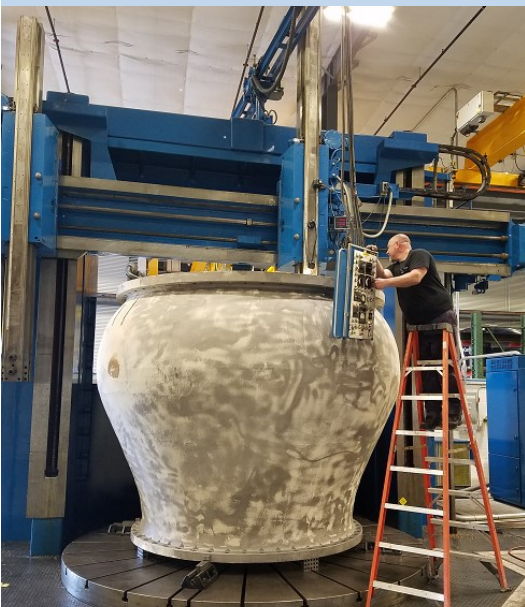
INDICATING DIFFUSER BOWL TO CHECK CONCENTRICITY OF REGISTERS AND MACHINE CASE RING FIT

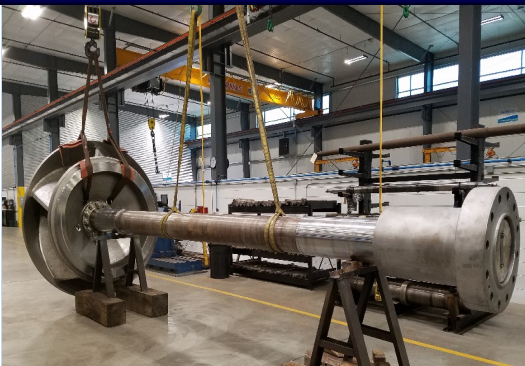
ROTOR ASSEMBLED AND READY TO BE BALANCED

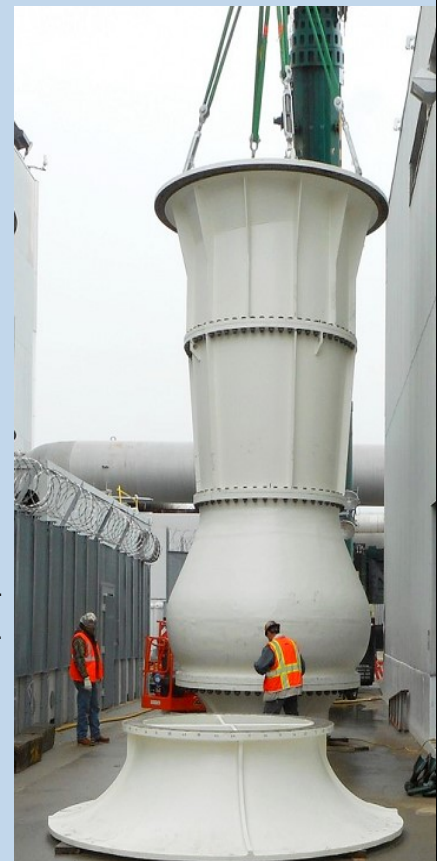
AFTER BEING ASSEMBLED OUTSIDE PUMP IS BEING LIFTED TO INSTALL IN PUMP BASIN
