**IRRIGATION SYSTEM DOWN? AVOID THE BROWN!
EMERGENCY SOLUTION SAVES GREEN AND GREENS**

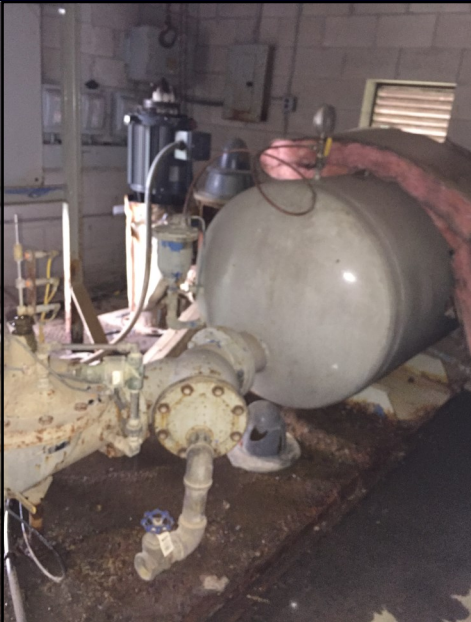
FAILED ORIGINAL PUMP SYSTEM

PROBLEM: A local golf course, in a panic, called Kennedy Industries and reported they had lost all of their irrigation pumps due to catastrophic failure. The course had no practical way to get water to its fairways and greens. The course was at imminent risk of losing the entire course and its business for the entire season as high temperatures and a lack of precipitation were only days away. They needed a solution and fast!

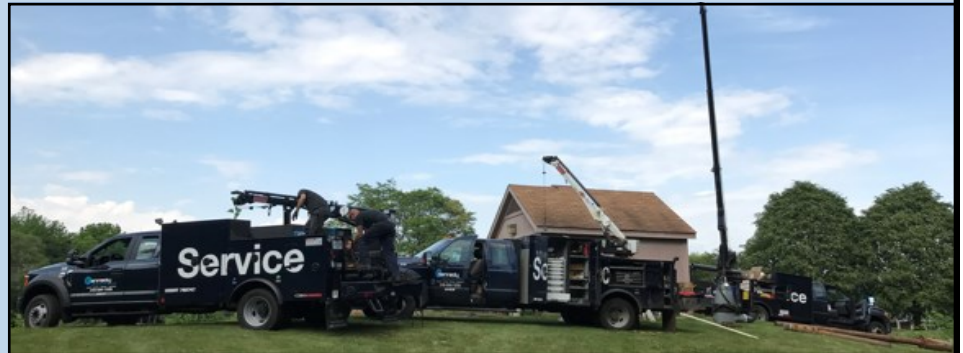
ALL HANDS ON DECK, KENNEDY DISPATCHES THREE SERVICE TECHS

SOLUTION: Our team immediately constructed a plan, and a day later had a crew out demolishing the old skid. A rental Flygt NS-3301.180 85HP submersible pump paired with a variable frequency drive unit was custom installed to provide 400 GPM @ 90 psi allowing the course to irrigate the fairways and greens. This will allow the facility to remain open for the summer and preserve their business for the 2017 season. The customer has a new pump skid on order that will be installed after the 2017 season. The project required extensive on-site demolition and fabrication to allow the pump to fit the well, but it was no problem for Kennedy field service team. With the course back up and running the customer can now focus on making green rather than losing it.

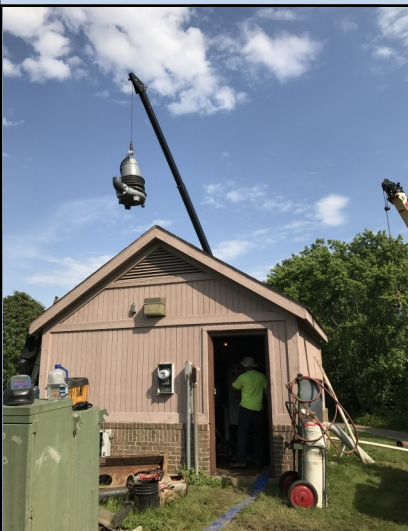
LOWERING NEW PUMP

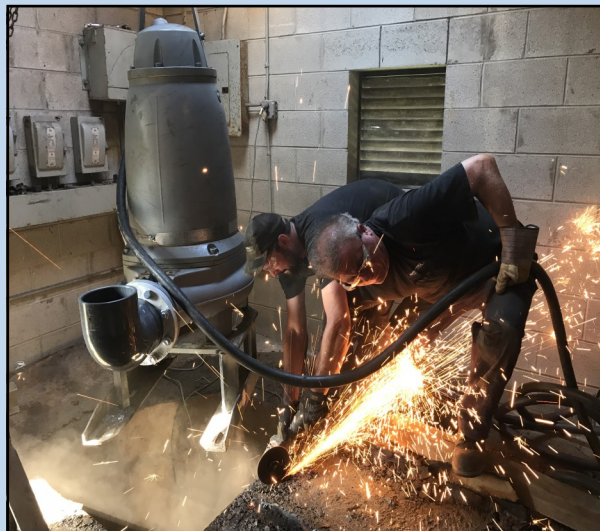
CUSTOM FABRICATION

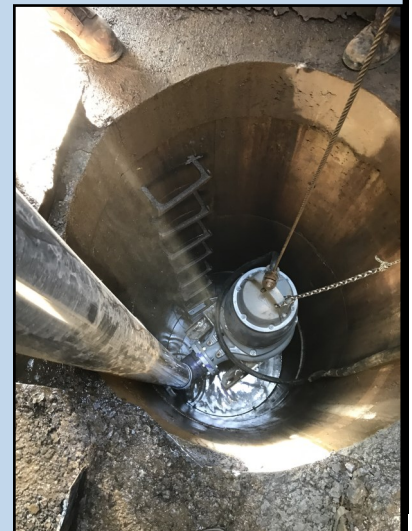
NEW PUMP IN WET WELL
